Item No.70. TORQUE WRENCH SETTING - JAVELIN & JUPITER MODELS

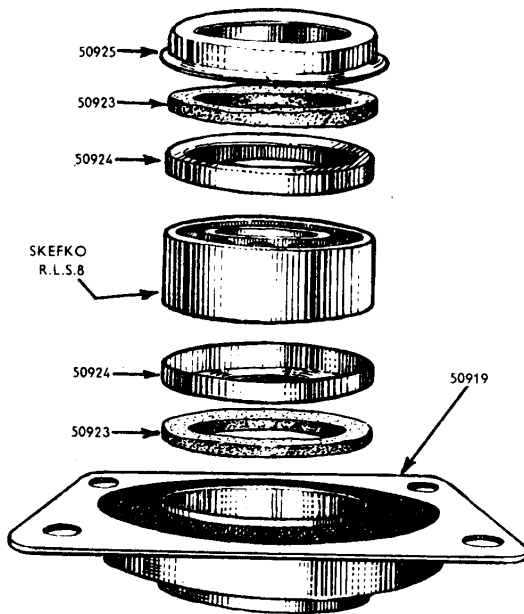
ORDER OF MIDSHIP
BEARING ASSEMBLY

that the rim is peened over evenly around the full perimeter of the rim.
