**RECTIFICATION OF WATER LEAKS ON MOULDINGS**

**INTERCHANGEABILITY OF EXHAUST SYSTEM COMPONENTS**

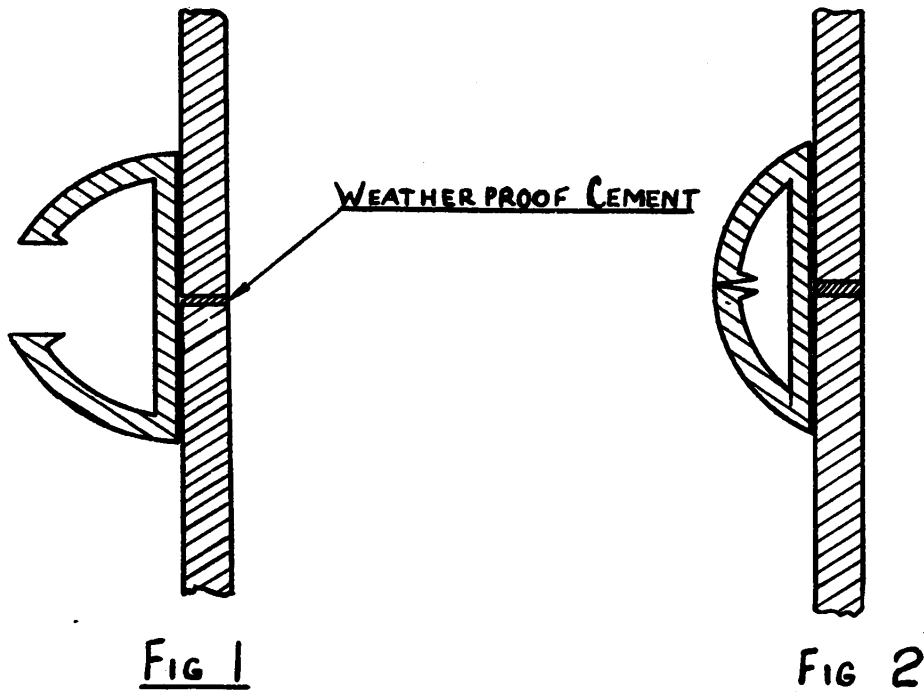
Leakage into the body may occur through faulty panel joints. These are weather proofed with a sealing cement and covered with closed down mouldings, fixed in position with serrated nails.

To eliminate this trouble remove the moulding from the body panel and apply Bostik or any other good weather-proofing cement evenly between the panels.

Whilst the jointing is still "tacky" an entirely new moulding must be affixed and closed down in position. See Fig. 2.
